NET+50 Errata

Part number/version: 90000283_L
Release date: February 2006
www.digi.com

For use in conjunction with:
NET+50/20M Hardware Reference
Part number/version: 90000281_A
Release date: September 2002

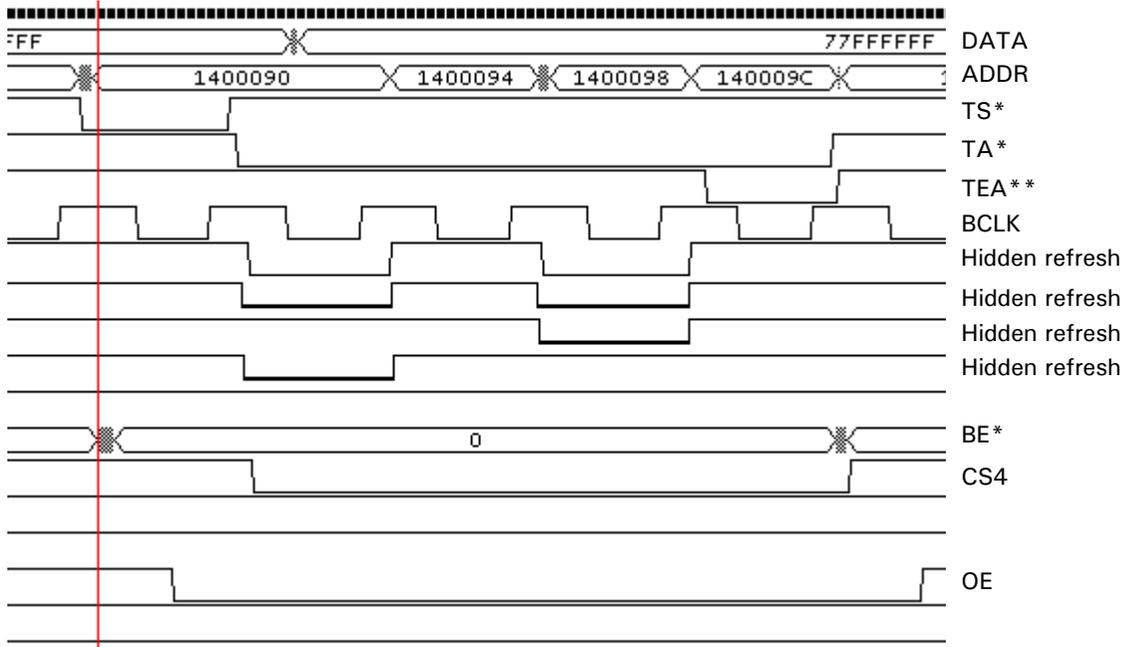
Figure 1: 2-111 burst transfer

SRAM sync burst cycle during DMA

When a chip select is set as a synchronous read with the WAIT set to 0 and the BCYC field set to 00, the chip produces the correct 2-111 burst transfer:

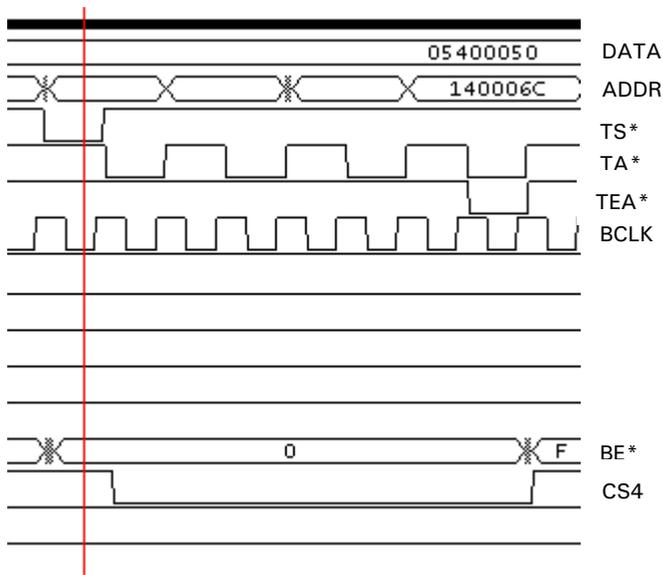
Figure 2: 2-222 burst transfer

An SRAM burst cycle transfer that occurs during a DMA transfer, however, will be a 2-222 burst transfer:

Workaround

None.
