NS7520 Errata

Part number/version: 90000352_L
Release date: February 2006
www.digi.com

For use in conjunction with:
NS7520 Hardware Reference
Part number/version: 90000353_C
Release date: September 2005

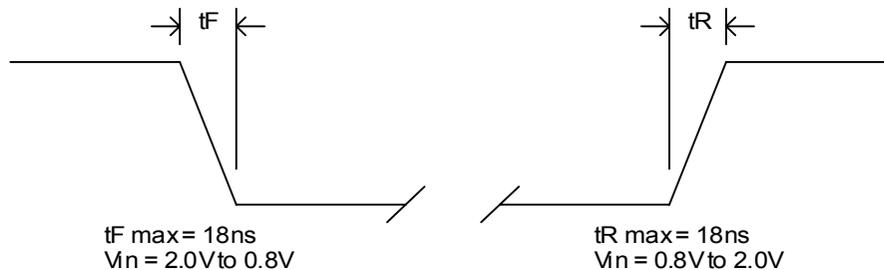
When the NS7520 is configured to use the PLL clock generator, the system clock can come up at 1/2 the configured frequency, or at a higher frequency – usually 64 MHz. When the PLLTST and BISTEN signals are set high with the SCANEN signal low, the PLL clock generator should produce the system clock based on the code it reads on address signals A[4:0]. on occasion, the system clock is either 1/2 the frequency or greater than the configured frequency due to the internal PLL circuitry not being properly reset.

Ensure that the RESET source has adequate fall/rise times and is free from glitches and ringing to prevent 64 MHz or other higher frequencies. This example shows rise and fall timing:
