NS9360

Errata

90000677-88_F

Release date: March 2008

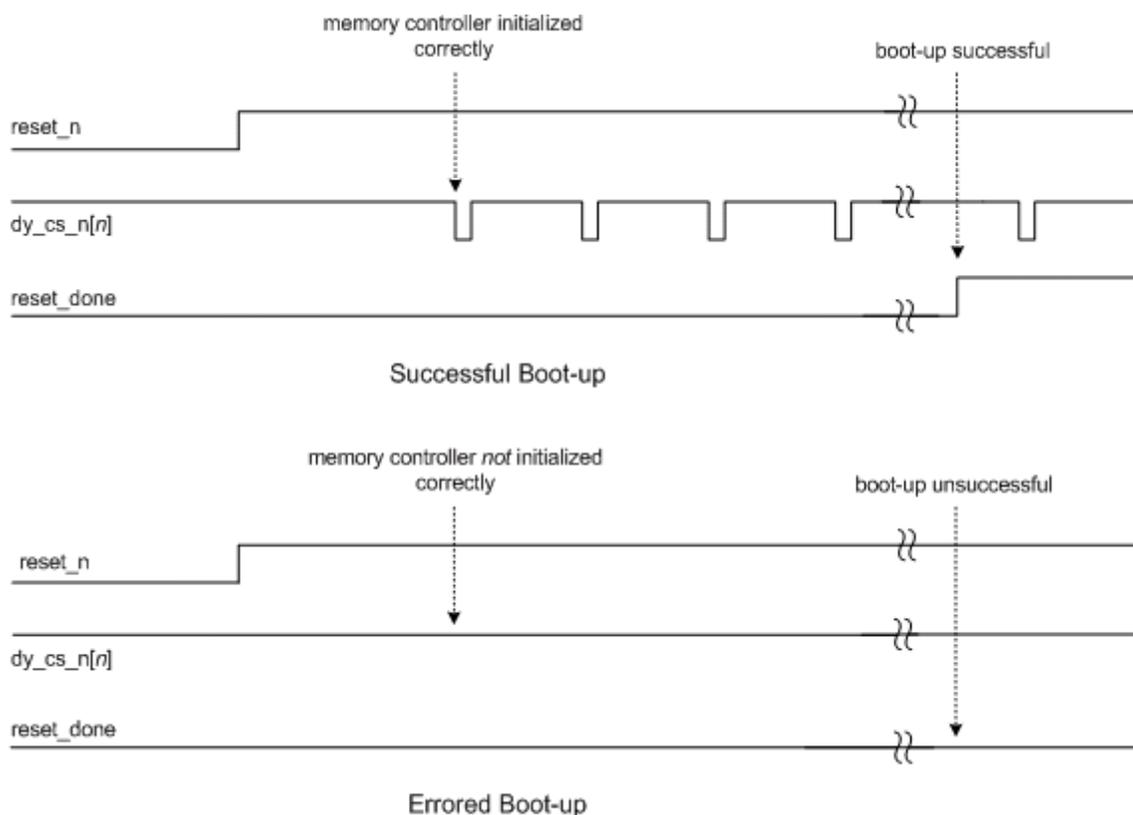
SPI boot fails intermittently during power-on because of an initialization error. As a result, a manual reset to the NS9360 can sometimes be required after the initial power-up reset. SPI boot works reliably from push button reset.

A failure can also occur if the software changes the system endian bit after boot-up (bit 3 in the Miscellaneous System Configuration register). This bit is set according to the bootstrap condition on gpio[44].

The next diagrams show the timing for a proper boot-up and for an errored boot-up sequence:

A board hardware work around can detect and recover from the error.

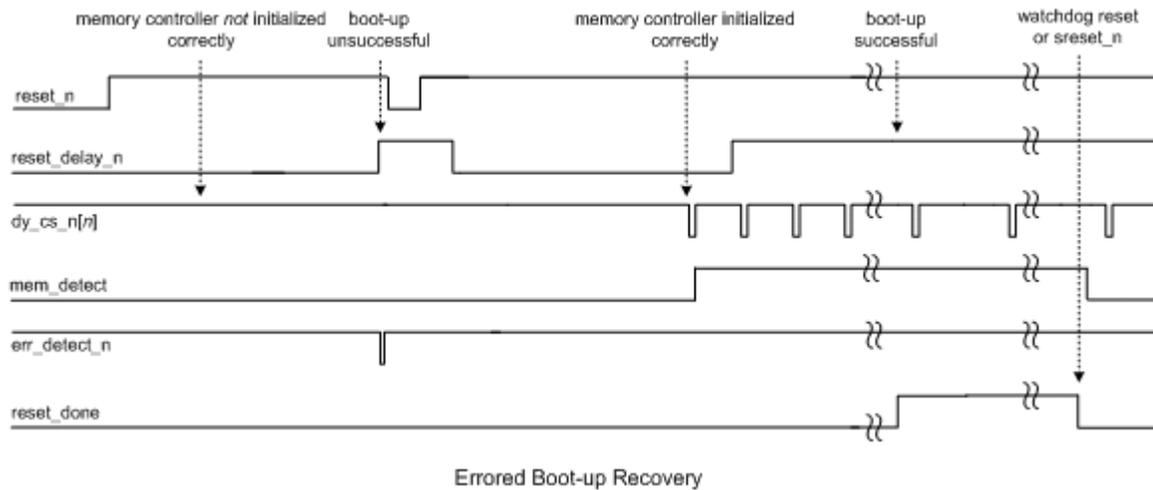
This timing diagram illustrates the recovery process:

The board hardware workaround circuit that detects the unsuccessful boot-up is shown next. Digi recommends that you use a spare dynamic memory chip select in the workaround circuit.

If the endian bit is never changed (bit 3 in the Miscellaneous System Configuration register), the circuit fed by reset_done (inverter, flip-flop and AND gate) can be omitted. If the err_detect_n flip-flop has a Schmitt trigger clock input the Schmitt trigger buffer can also be omitted.

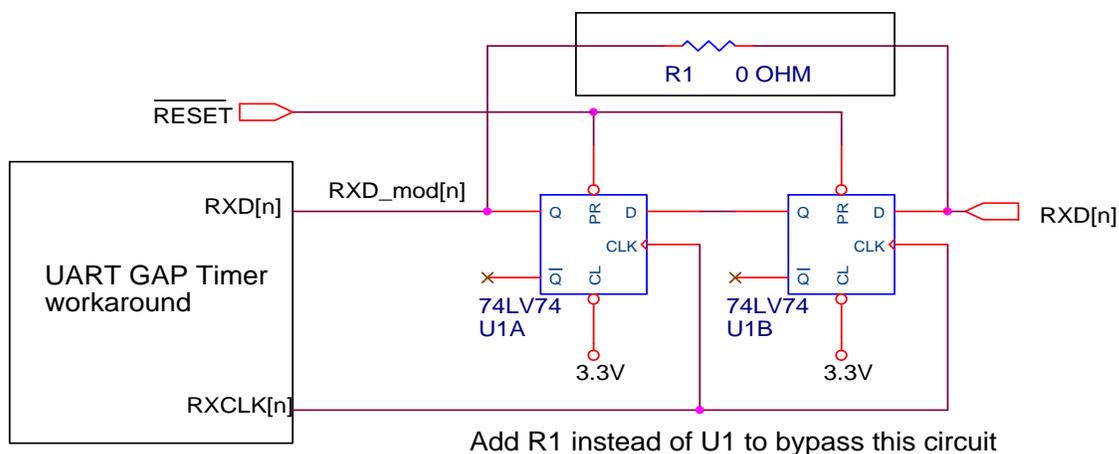
Workaround drawing

The start bit of a new character may not be detected when the character or buffer gap timer expires. Framing, parity, or data corruption occur when a start bit is missed.

A hardware workaround eliminates the possibility of receiving a start bit when a character or buffer gap timer is expiring. The workaround drives the baud clock off-chip and synchronizes the incoming data with this clock. As a result, the buffer and character gap timers and the next start bit have a fixed and known relationship with each other.

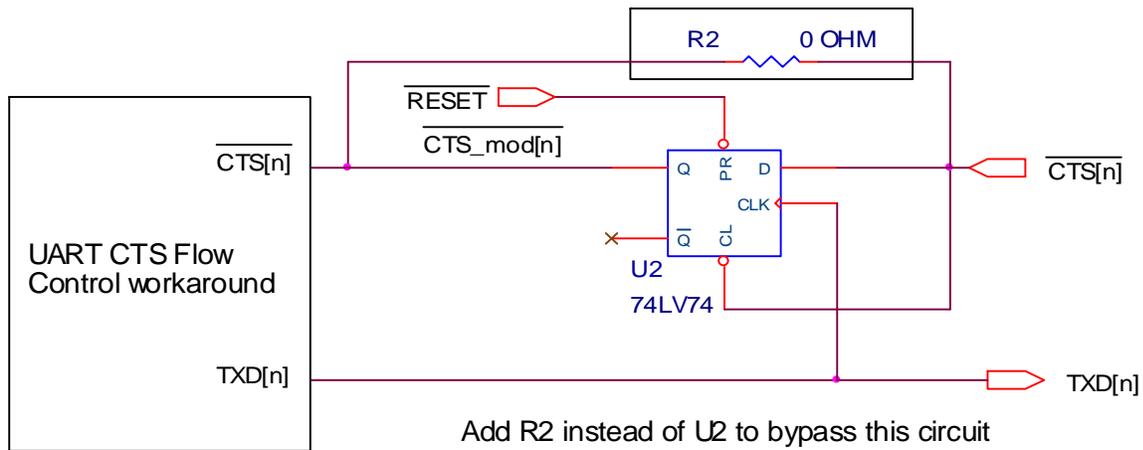
A problem occurs when the CTS flow control signal is de-asserted during the BCLK that begins processing a new character. This problem causes the previous character to be re-transmitted instead of getting the next character from the transmit FIFO.

Hardware workarounds: For each UART, externally clock the CTS signal with the Txd_n signal to guarantee that CTS will not be seen de-asserting at the start of a character.
