NS9750B-A1

Errata

*90000738, Rev F*

Release date: September 2006

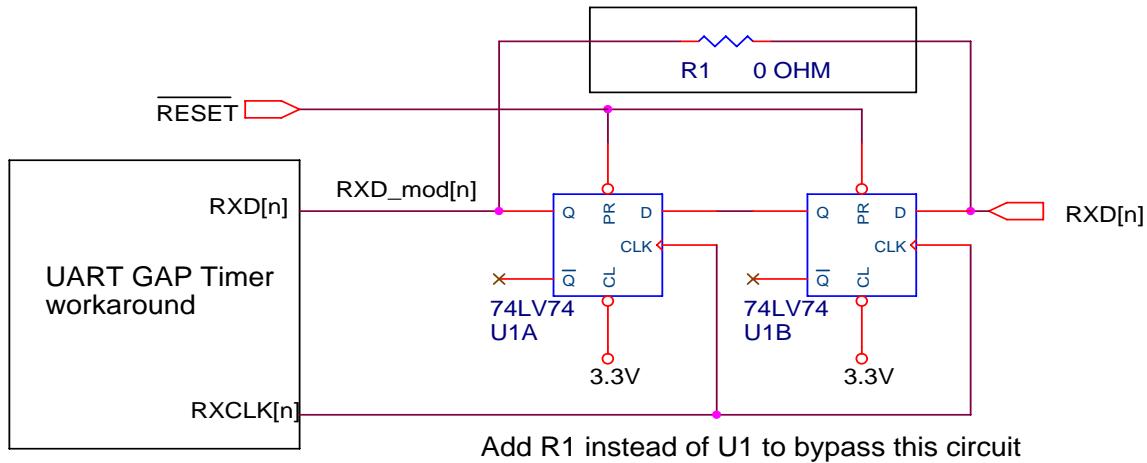
The start bit of a new character may not be detected when the character or buffer gap timer expires. Framing, parity, or data corruption occur when a start bit is missed.

A hardware workaround eliminates the possibility of receiving a start bit when a character or buffer gap timer is expiring. The workaround drives the baud clock off-chip and synchronizes the incoming data with this clock. As a result, the buffer and character gap timers and the next start bit have a fixed and known relationship with each other.

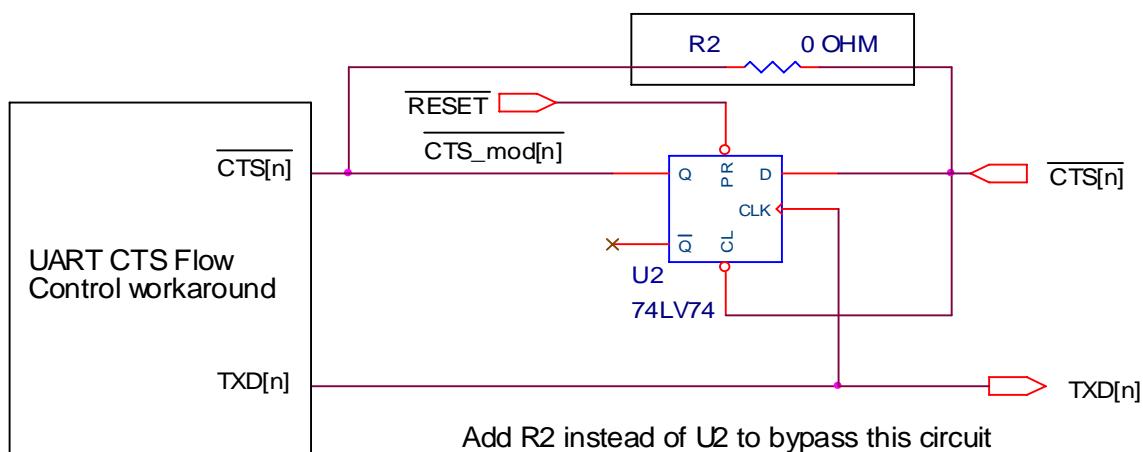
A problem occurs with the CTS flow control signal is de-asserted during the BCLK that begins processing a new character. This problem causes the previous character to be resent instead of getting the next character from the transmit FIFO.

**Hardware workaround:** For each UART, externally clock the CTS signal with the Txd\_n signal to guarantee that CTS will not be seen de-asserting at the start of a character.

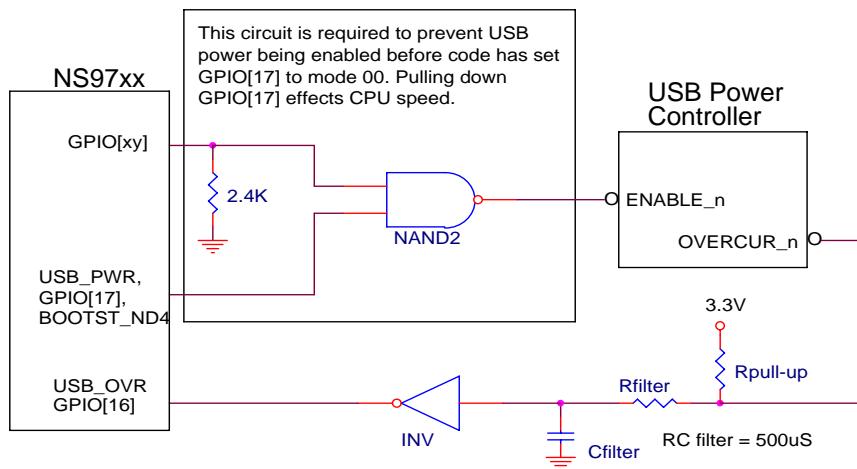
The USB PWR (power) control output requires additional external logic and GPIO to prevent USB power from being enabled from the time power is valid until the code has set the USB registers and selected gpio[17] to mode 00. The polarity of USB PWR is true high. Pulling down GPIO[17] to disable the USB power control changes the CPU bus speed because this pin is also bootstrap – ND4.

This figure shows a recommended logic workaround:
