NS9360 SPI Boot Hardware Workaround Application Note

May 2006

NS9360 SPI Boot hardware workaround

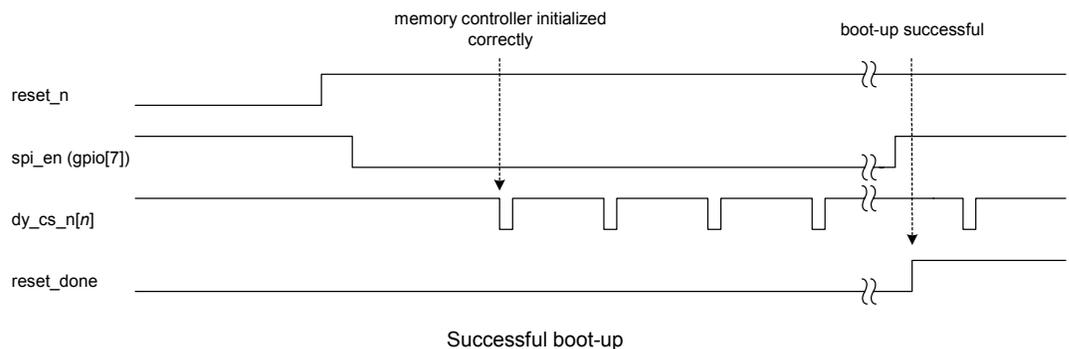
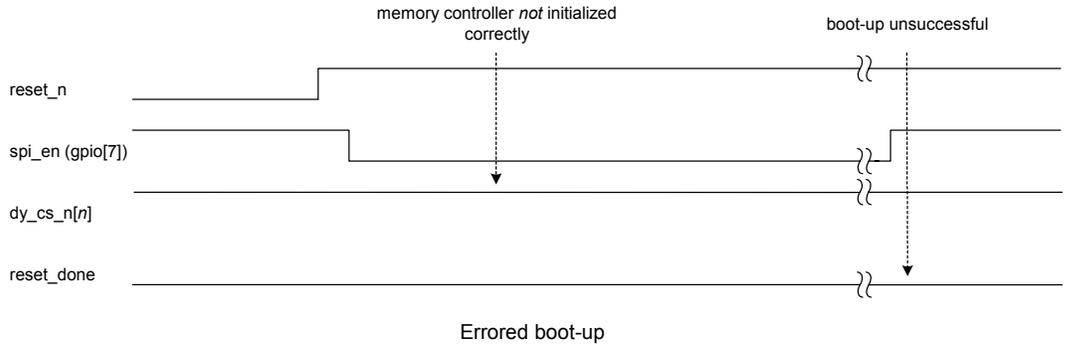
A hardware defect in the NS9360 can intermittently prevent proper startup when booting from a SPI EEPROM device. The source of the problem is the SPI Boot module in the NS9360, which can sometimes cause a system bus error when initializing the memory controller.

The next two timing diagrams show a successful boot-up and an errored boot-up sequence:

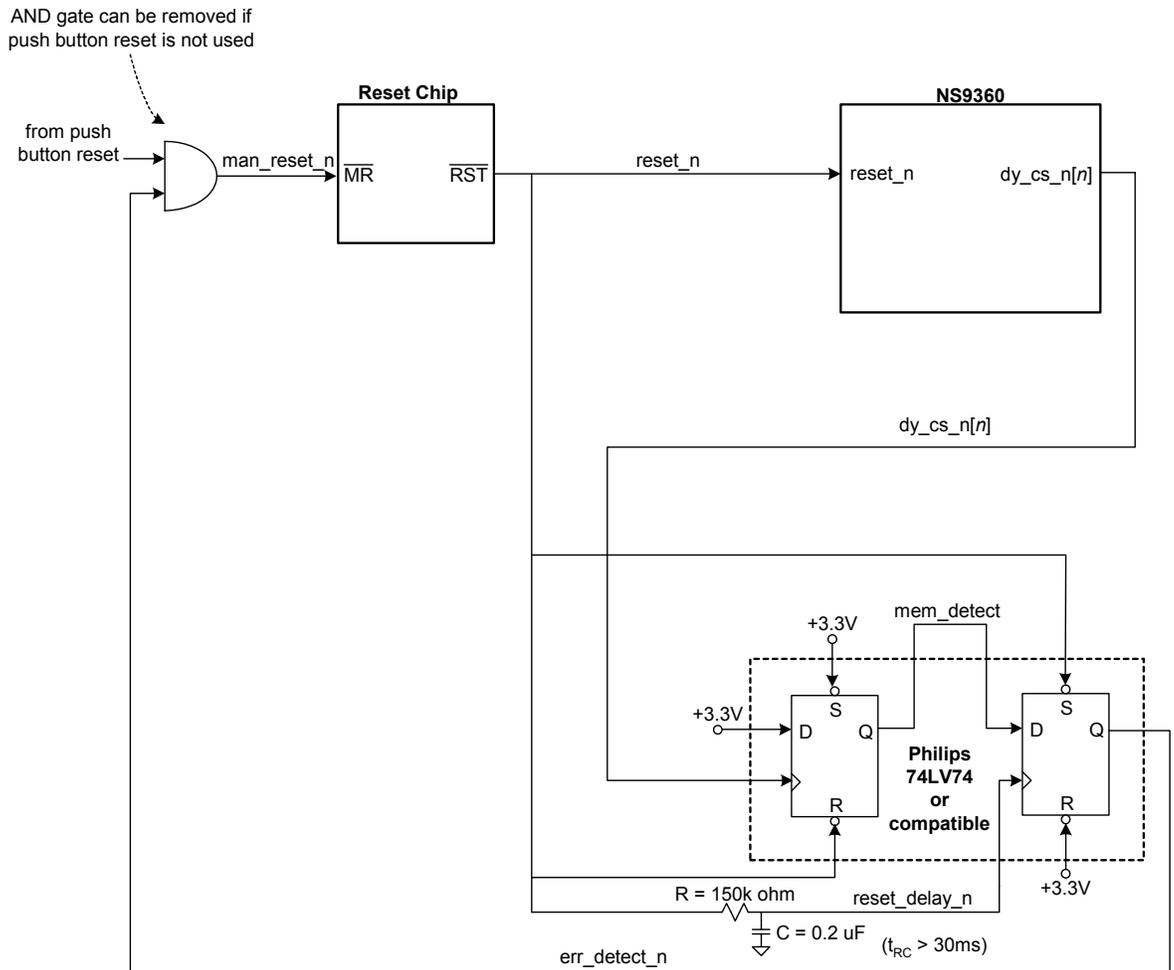
This figure shows the board workaround circuit to detect the unsuccessful boot-up. Digi recommends that you use a spare dynamic memory chip select in the workaround circuit.

A board hardware workaround can detect and recover from the error. When the error occurs, the NS9360 memory controller is not initialized and remains idle. The workaround detects the absence of activity on the SDRAM interface when the SPI EEPROM device is deselected. When detected, the NS9360 can be reset again, at which time it is guaranteed that the SPI Boot module correctly will initialize the memory controller. The board hardware workaround requires one or two components, depending on the board reset circuit configuration.

Note: The Philip's 74LV74 has a Schmitt trigger required for the slow rise time of reset_delay_n.

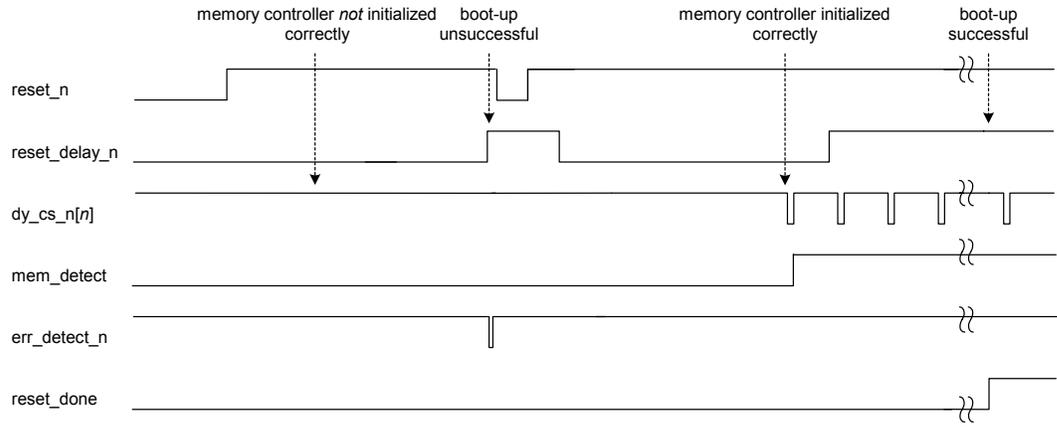
Errored boot-up recovery

This timing diagram shows the recovery process:
