NS9750B-0

Errata

90000530, Rev E

Release date: January 2006

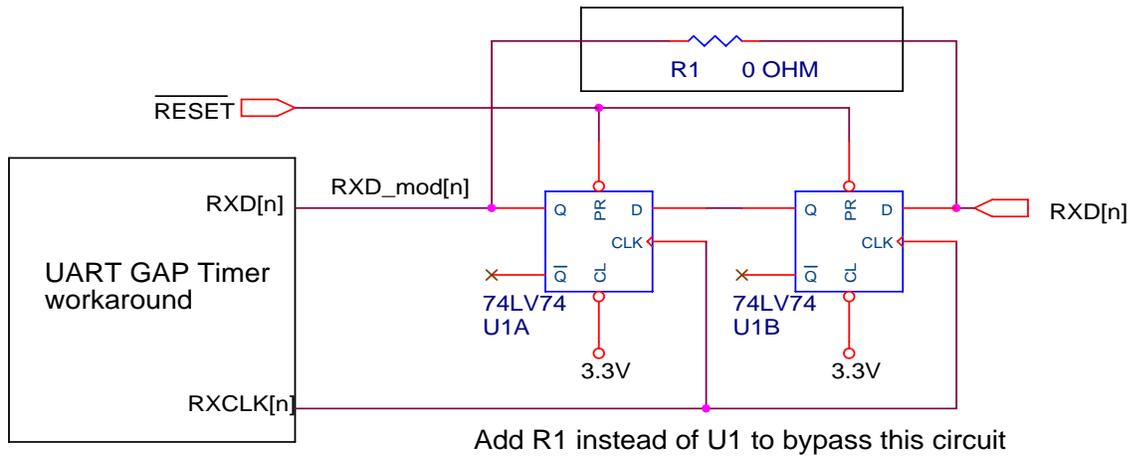
UART gap timer

The start bit of a new character may not be detected when the character or buffer gap timer expires. Framing, parity, or data corruption occur when a start bit is missed.

A hardware workaround eliminates the possibility of receiving a start bit when a character or buffer gap timer is expiring. The workaround drives the baud clock off-chip and synchronizes the incoming data with this clock. As a result, the buffer and character gap timers and the next start bit have a fixed and known relationship with each other.

- The TMODE bit in the Bit-rate register must be cleared.
- Baud rates are limited to those available in x16 mode
- Baud rates with a divisor of 0 are not possible for all CPU frequencies. This translates to a maximum baud rate of 460k in x16 mode.
- Baud rates with a divisor of 1 are not possible for CPU frequencies below 147MHz. This translates to a baud rate of 230k in x16 mode.
- The buffer and character gaps must be an even multiple of the sample clock period. For a 96000bps UART in x16 UART mode, the equation is:
- $\text{Timer increment} = ((1/9600) / 16) \times 2 = 13.020\mu\text{s}$
- One GPIO per UART is required to output the baud clock. The baud clock can be output on the RI pin on each UART. This function is controlled by the RXEXT bit (27) in each Serial Bit-rate register.

If multiple UARTs are running at the same baud rate, one baud clock can be used for the multiple UARTs.

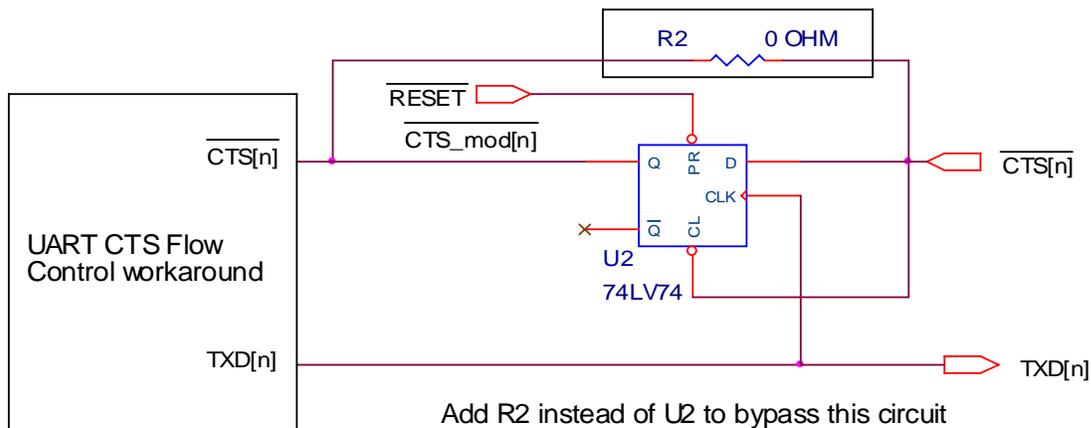
UART CTS-related transmit data errors

A problem occurs when the CTS flow control signal is de-asserted during the BCLK that begins processing a new character. This problem causes the previous character to be re-transmitted instead of getting the next character from the transmit FIFO.

Hardware workaround: For each UART, externally clock the CTS signal with the Txd_n signal to guarantee that CTS will not be seen de-asserting at the start of a character.

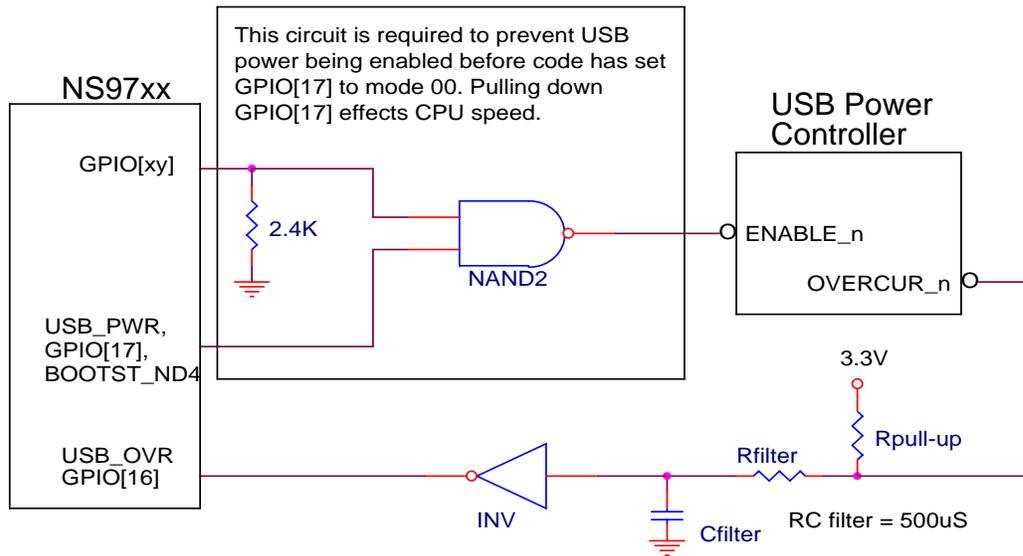
USB OVR and USB PWR

The USB PWR (power) control output requires additional external logic and GPIO to prevent USB power from being enabled from the time power is valid until the code has set the USB registers and selected gpio[17] to mode 00. The polarity of USB PWR is true high. Pulling down GPIO[17] to disable the USB power control changes the CPU bus speed because this pin is also bootstrap – ND4.

Designs that add the additional GPIO to prevent USB power-on during startup would require the BSP, as a final step, to set this GPIO to output a 1.

This drawing shows a recommended logic workaround:
