NS9750B-A1

Errata

90000738, Rev E

Release date: January 2006

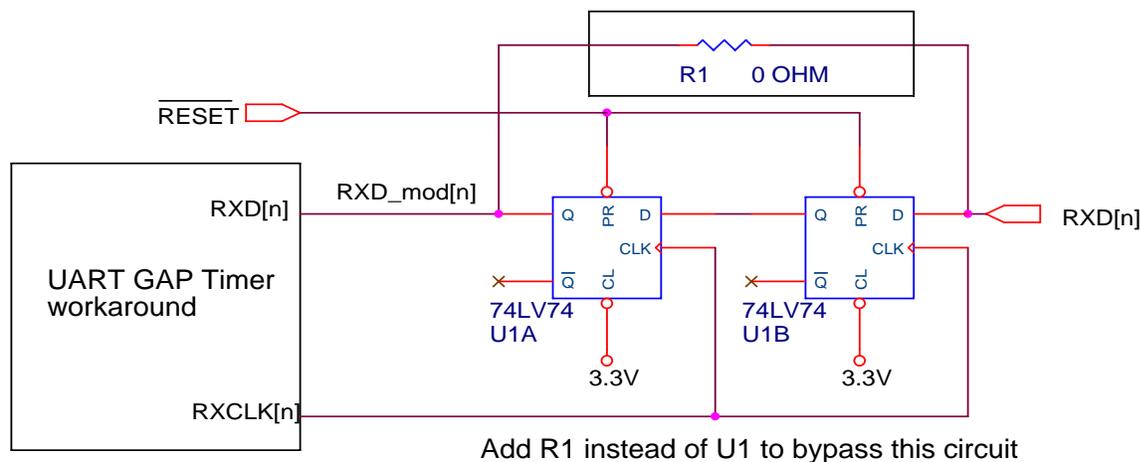
UART gap timer

The start bit of a new character may not be detected when the character or buffer gap timer expires. Framing, parity, or data corruption occur when a start bit is missed.

Hardware workaround:

A hardware workaround eliminates the possibility of receiving a start bit when a character or buffer gap timer is expiring. The workaround drives the baud clock off-chip and synchronizes the incoming data with this clock. As a result, the buffer and character gap timers and the next start bit have a fixed and known relationship with each other.

Limitations:

- The TMODE bit in the Bit-rate register must be cleared.
- Baud rates are limited to those available in x16 mode
- Baud rates with a divisor of 0 are not possible for all CPU frequencies. This translates to a maximum baud rate of 460k in x16 mode.

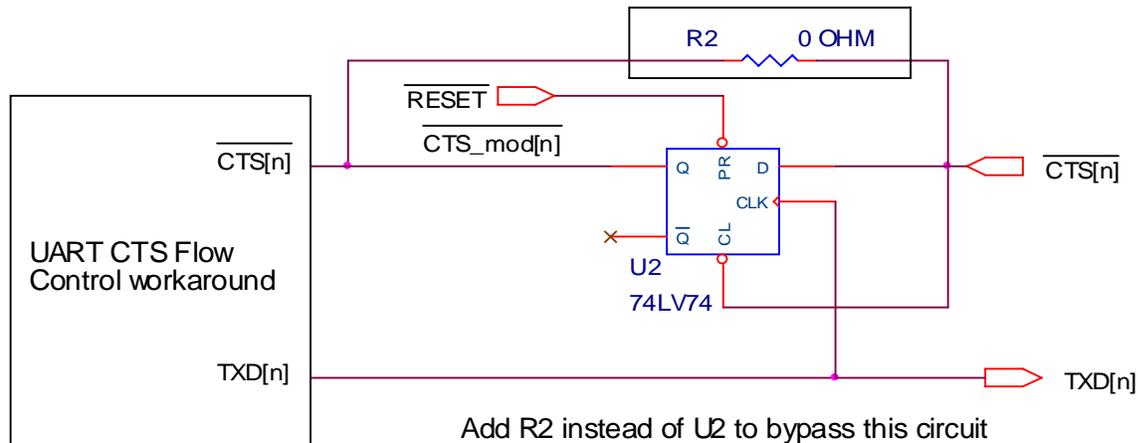
UART CTS-related transmit data errors

A problem occurs with the CTS flow control signal is de-asserted during the BCLK that begins processing a new character. This problem causes the previous character to be resent instead of getting the next character from the transmit FIFO.

Hardware workaround: For each UART, externally clock the CTS signal with the Txd_n signal to guarantee that CTS will not be seen de-asserting at the start of a character.

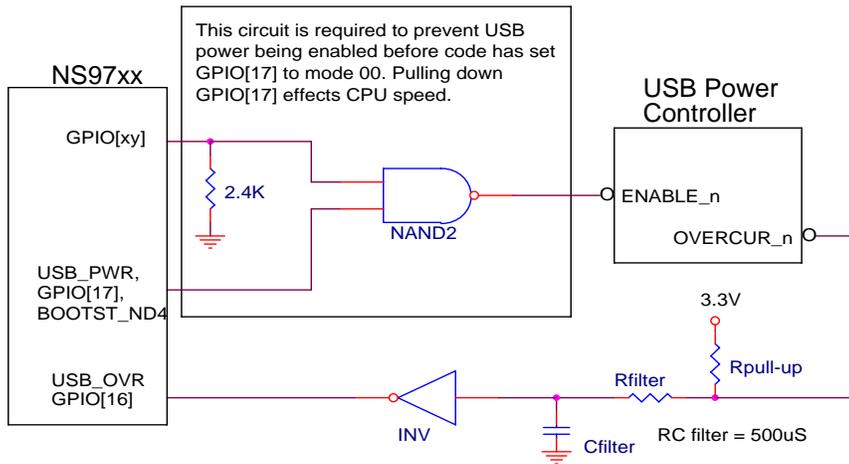
USB OVR and USB PWR

The USB PWR (power) control output requires additional external logic and GPIO to prevent USB power from being enabled from the time power is valid until the code has set the USB registers and selected gpio[17] to mode 00. The polarity of USB PWR is true high. Pulling down GPIO[17] to disable the USB power control changes the CPU bus speed because this pin is also bootstrap – ND4.

Designs that add the additional GPIO to prevent USB power-on during startup would require the BSP, as a final step, to set this GPIO to output a 1.

This figure shows a recommended logic workaround:
