NS9775B-0

Errata

90000527, Rev E

Release date: January 2006

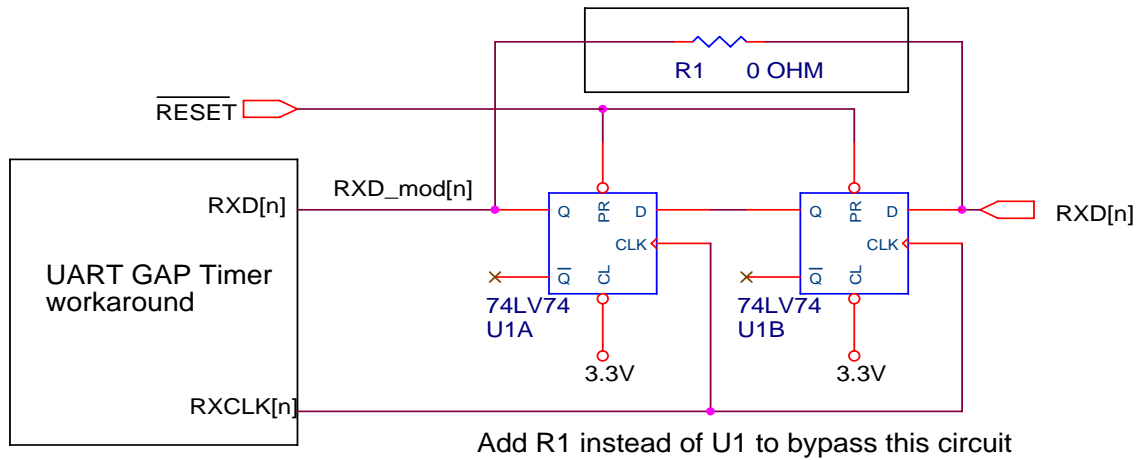
UART gap timer

The start bit of a new character may not be detected when the character or buffer gap timer expires. Framing, parity, or data corruption occur when a start bit is missed.

A hardware workaround eliminates the possibility of receiving a start bit when a character or buffer gap timer is expiring. The workaround drives the baud clock off-chip and synchronizes the incoming data with this clock. As a result, the buffer and character gap timers and the next start bit have a fixed and known relationship with each other.

- The TMODE bit in the Bit-rate register must be cleared.
- Baud rates are limited to those available in x16 mode
- Baud rates with a divisor of 0 are not possible for all CPU frequencies. This translates to a maximum baud rate of 460k in x16 mode.
- Baud rates with a divisor of 1 are not possible for CPU frequencies below 147MHz. This translates to a baud rate of 230k in x16 mode.
- The buffer and character gaps must be an even multiple of the sample clock period. For a 96000bps UART in x16 UART mode, the equation is:
- $\text{Timer increment} = ((1/9600) / 16) \times 2 = 13.020\mu\text{s}$
- One GPIO per UART is required to output the baud clock. The baud clock can be output on the RI pin on each UART. This function is controlled by the RXEXT bit (27) in each Serial Bit-rate register.

If multiple UARTs are running at the same baud rate, one baud clock can be used for the multiple UARTs.

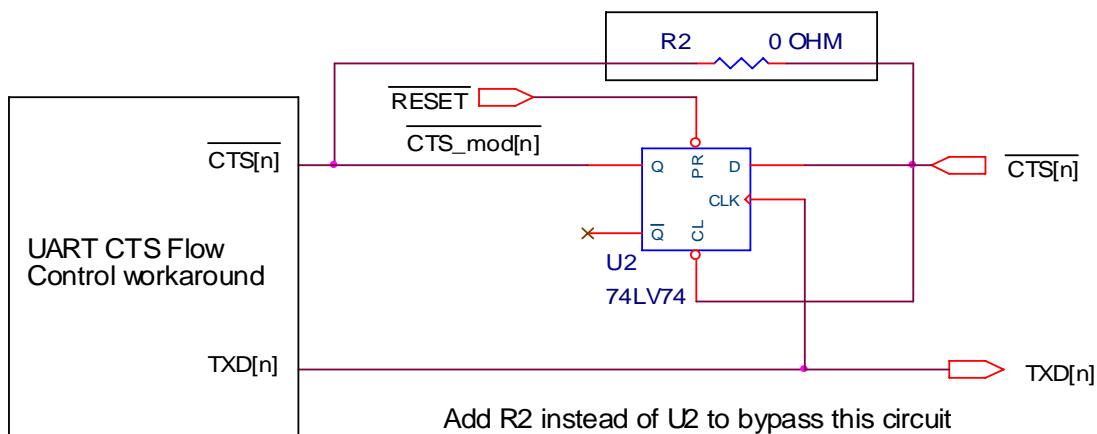
UART CTS-related transmit data errors

A problem occurs when the CTS flow control signal is de-asserted during the BCLK that begins processing a new character. This problem causes the previous character to be re-transmitted instead of getting the next character from the transmit FIFO.

Hardware workaround: For each UART, externally clock the CTS signal with the Txd_n signal to guarantee that CTS will not be seen de-asserting at the start of a character.

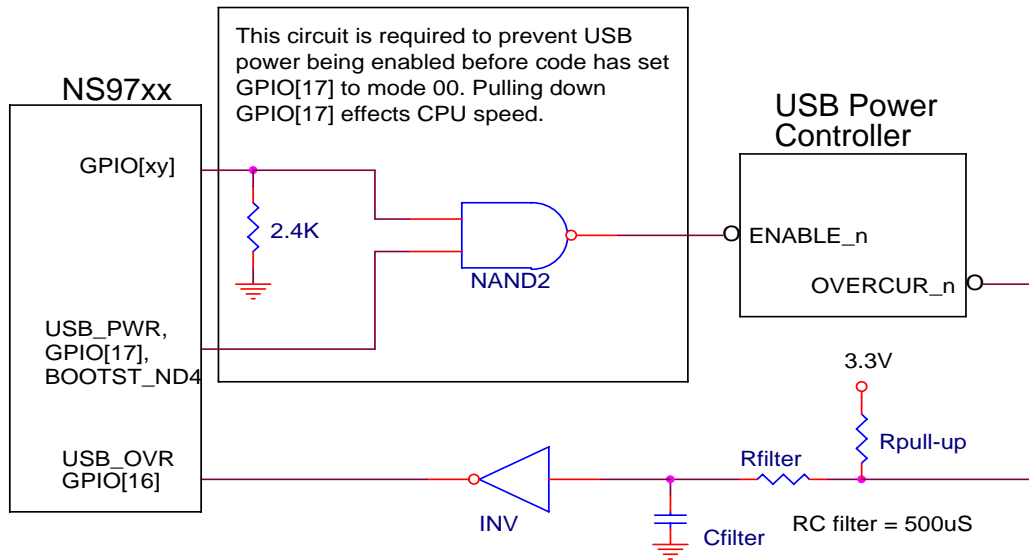
USB OVR and USB PWR

The USB PWR (power) control output requires additional external logic and GPIO to prevent USB power from being enabled from the time power is valid until the code has set the USB registers and selected gpio[17] to mode 00. The polarity of USB PWR is true high. Pulling down GPIO[17] to disable the USB power control changes the CPU bus speed because this pin is also bootstrap – ND4.

Designs that add the additional GPIO to prevent USB power-on during startup would require the BSP, as a final step, to set this GPIO to output a 1.

This drawing shows a recommended logic workaround:
