NET+50 Errata

Part number/version: 90000283_L
Release date: February 2006
www.digi.com

For use in conjunction with:
NET+50/20M Hardware Reference
Part number/version: 90000281_A
Release date: September 2002

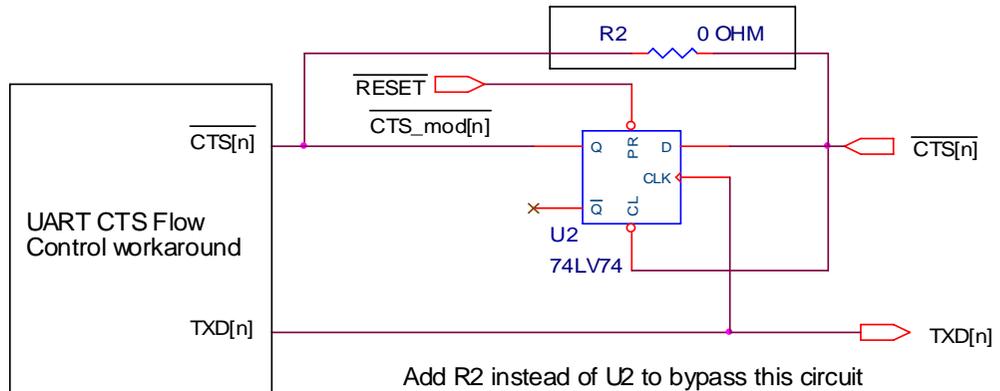
A problem occurs when the CTS flow control signal is de-asserted during the BCLK that begins processing a new character. This problem causes the previous character to be re-transmitted instead of getting the next character from the transmit FIFO.

For each UART, externally clock the CTS signal with the Txd_n signal to guarantee that CTS will not be seen de-asserting at the start of a character.
