Digi XBee® Industrial Gateway Telit Modem Firmware Update - Verizon

Update Guide

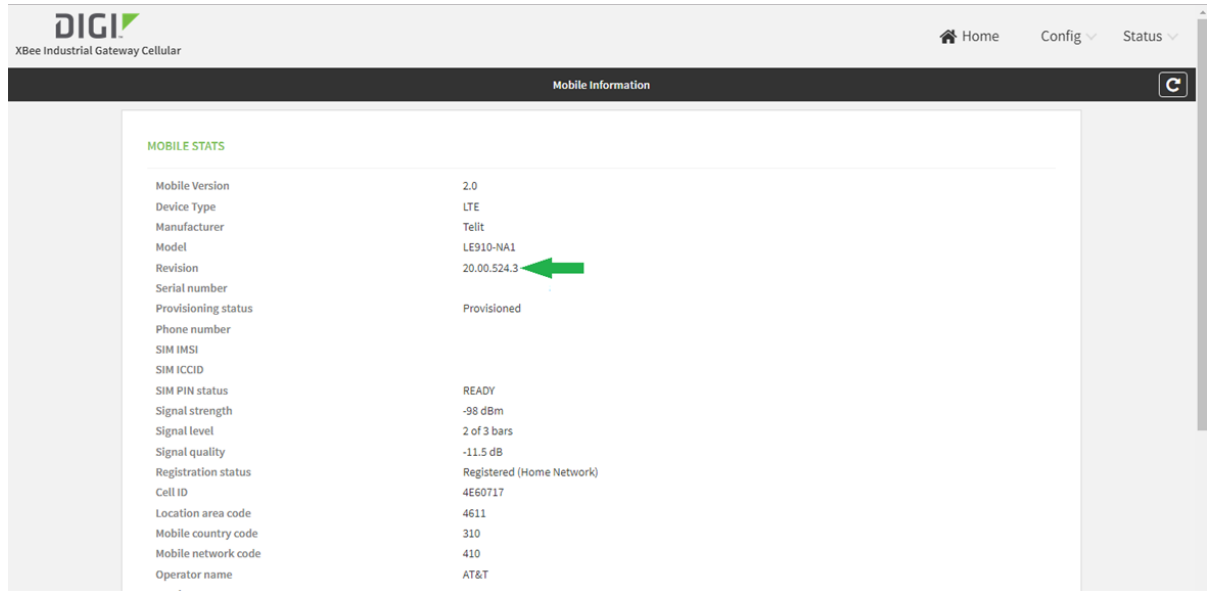
1. Open a web browser and navigate to <https://remotemanager.digi.com>.
2. Log in to your account.
3. In the **Devices** tab in Remote Manager, find your device. Double-click on the device entry to display the device properties.
4. Click the **Edit Device Configuration** button.
5. In the new window that opens, select **Mobile information** under **System Information**.
6. Take note of the **Revision** field on the page.

MOBILE STATS	
Mobile Version	2.0
Device Type	LTE
Manufacturer	Telit
Model	LE910-NA1
Revision	20.00.524.3
Serial number	
Provisioning status	Provisioned
Phone number	
SIM IMSI	
SIM ICCID	
SIM PIN status	READY
Signal strength	-98 dBm
Signal level	2 of 3 bars
Signal quality	-11.5 dB
Registration status	Registered (Home Network)
Cell ID	4E60717
Location area code	4611
Mobile country code	310
Mobile network code	410
Operator name	AT&T

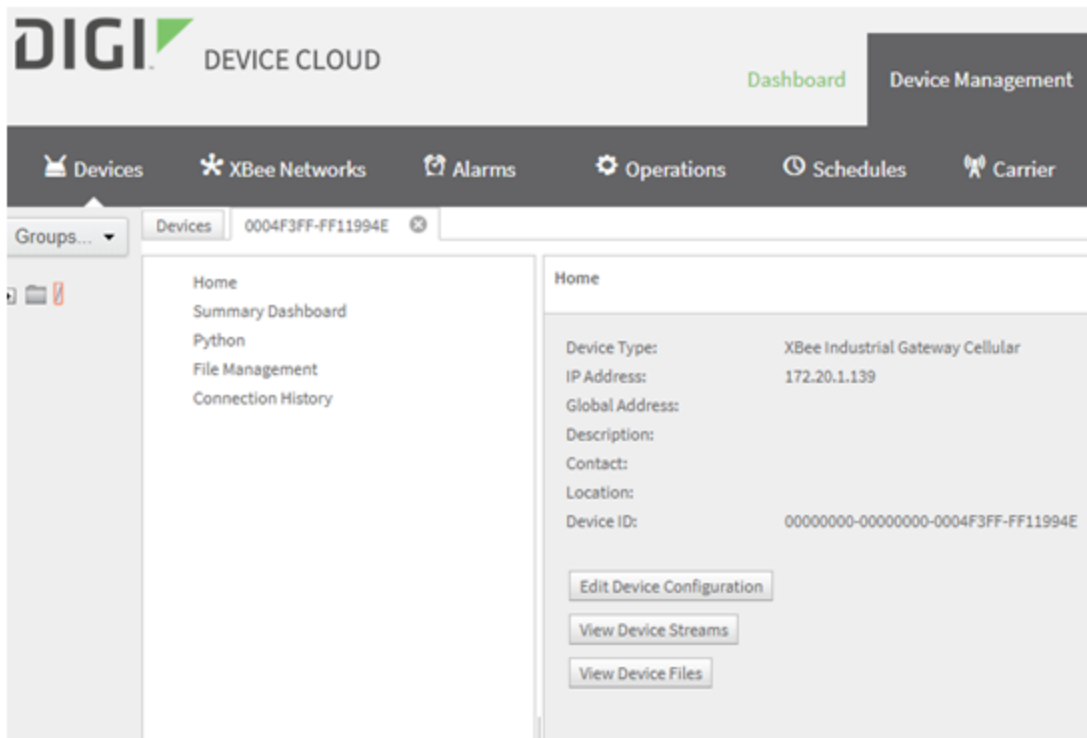
1. Open a web browser and navigate to <https://remotemanager.digi.com>.
2. Log into your account.
3. Click on the **Device Management** tab.
4. Find your device using the device ID.
5. Double-click to open your device.
6. Click **Edit Device Configurations**.

The device ID looks like: 00000000-00000000-0004F3FF-FFxxxxxx. It contains the MAC address of the modem. You will need the device ID later to start the FOTA process.

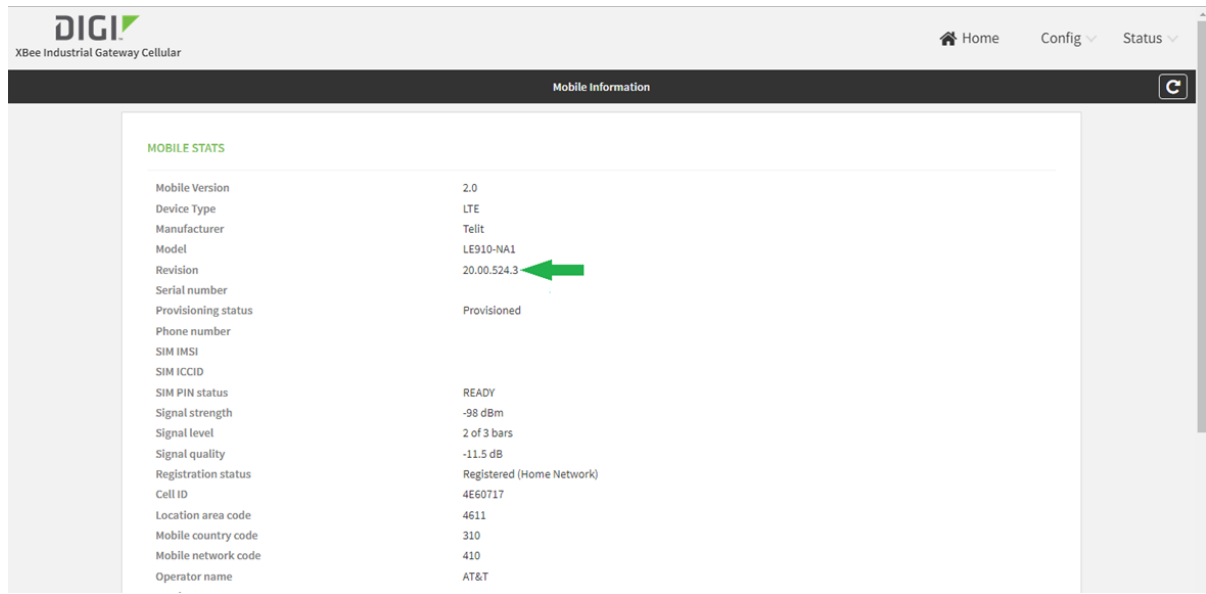
1. In Digi Remote Manager, select **Mobile information** under **System Information**.
2. Note the current **Revision**.

The desired revision is 20.00.015.0 for a module with a Verizon SIM or 20.00.525.2 for a module with a non-Verizon SIM. The Verizon firmware must be updated.

MOBILE STATS	
Mobile Version	2.0
Device Type	LTE
Manufacturer	Telit
Model	LE910-NA1
Revision	20.00.524.3
Serial number	
Provisioning status	Provisioned
Phone number	
SIM IMSI	
SIM ICCID	
SIM PIN status	READY
Signal strength	-98 dBm
Signal level	2 of 3 bars
Signal quality	-11.5 dB
Registration status	Registered (Home Network)
Cell ID	4E60717
Location area code	4611
Mobile country code	310
Mobile network code	410
Operator name	AT&T

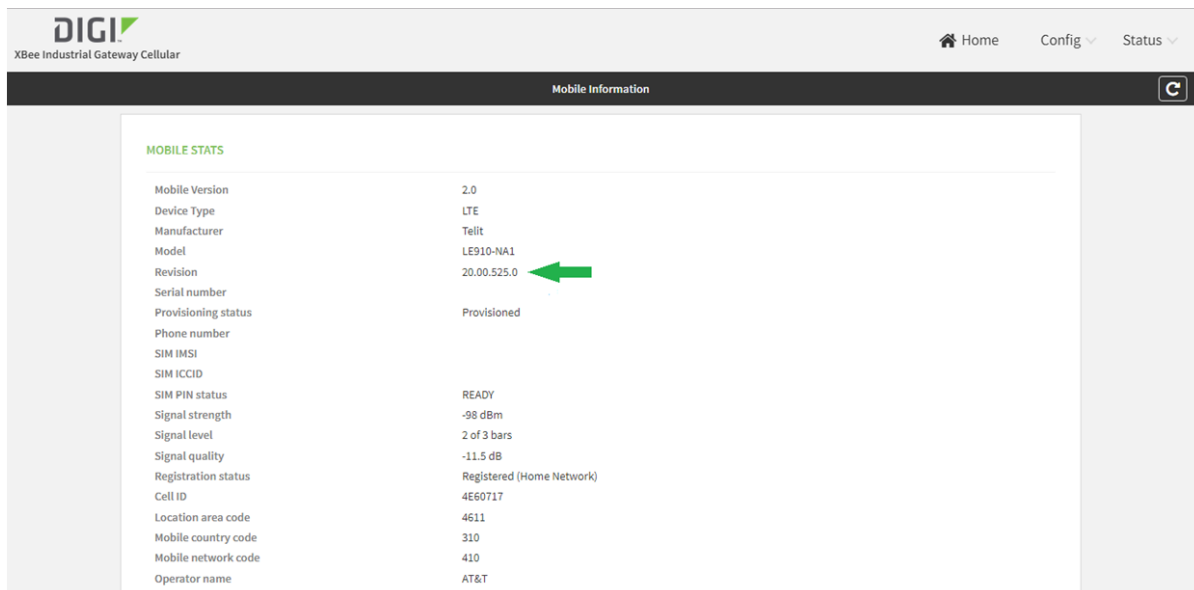
1. Confirm the new modem firmware revision. See [Step 1: Find the modem revision](#) for information about finding the revision.
2. Note the new **Revision**, which should now be 20.00.015.0 (Verizon) or 20.00.525.2 (other North American carriers).

MOBILE STATS	
Mobile Version	2.0
Device Type	LTE
Manufacturer	Telit
Model	LE910-NA1
Revision	20.00.525.0
Serial number	
Provisioning status	Provisioned
Phone number	
SIM IMSI	
SIM ICCID	
SIM PIN status	READY
Signal strength	-98 dBm
Signal level	2 of 3 bars
Signal quality	-11.5 dB
Registration status	Registered (Home Network)
Cell ID	4E60717
Location area code	4611
Mobile country code	310
Mobile network code	410
Operator name	AT&T
