## PRODUCT NOTICE # 101129

XBee-PRO XSC Firmware Update

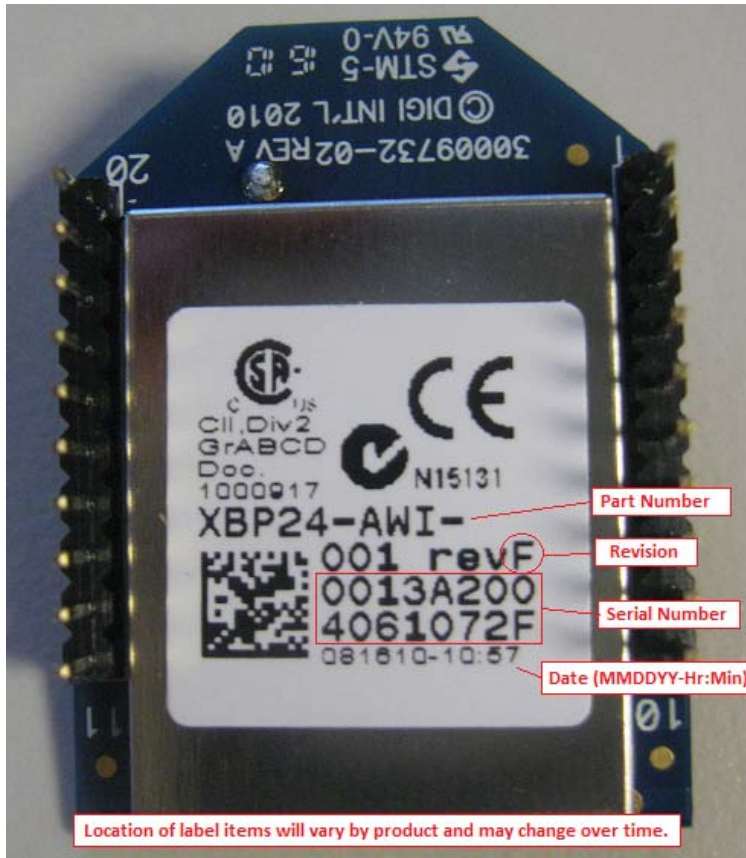
See page 2 of this PCN for a sample XBee label and how to find the Revision and other relevant information.
