# Test a WR41v1 Router

**How to test a WR41v1 router step by step.**

Technical Support  
March 2016

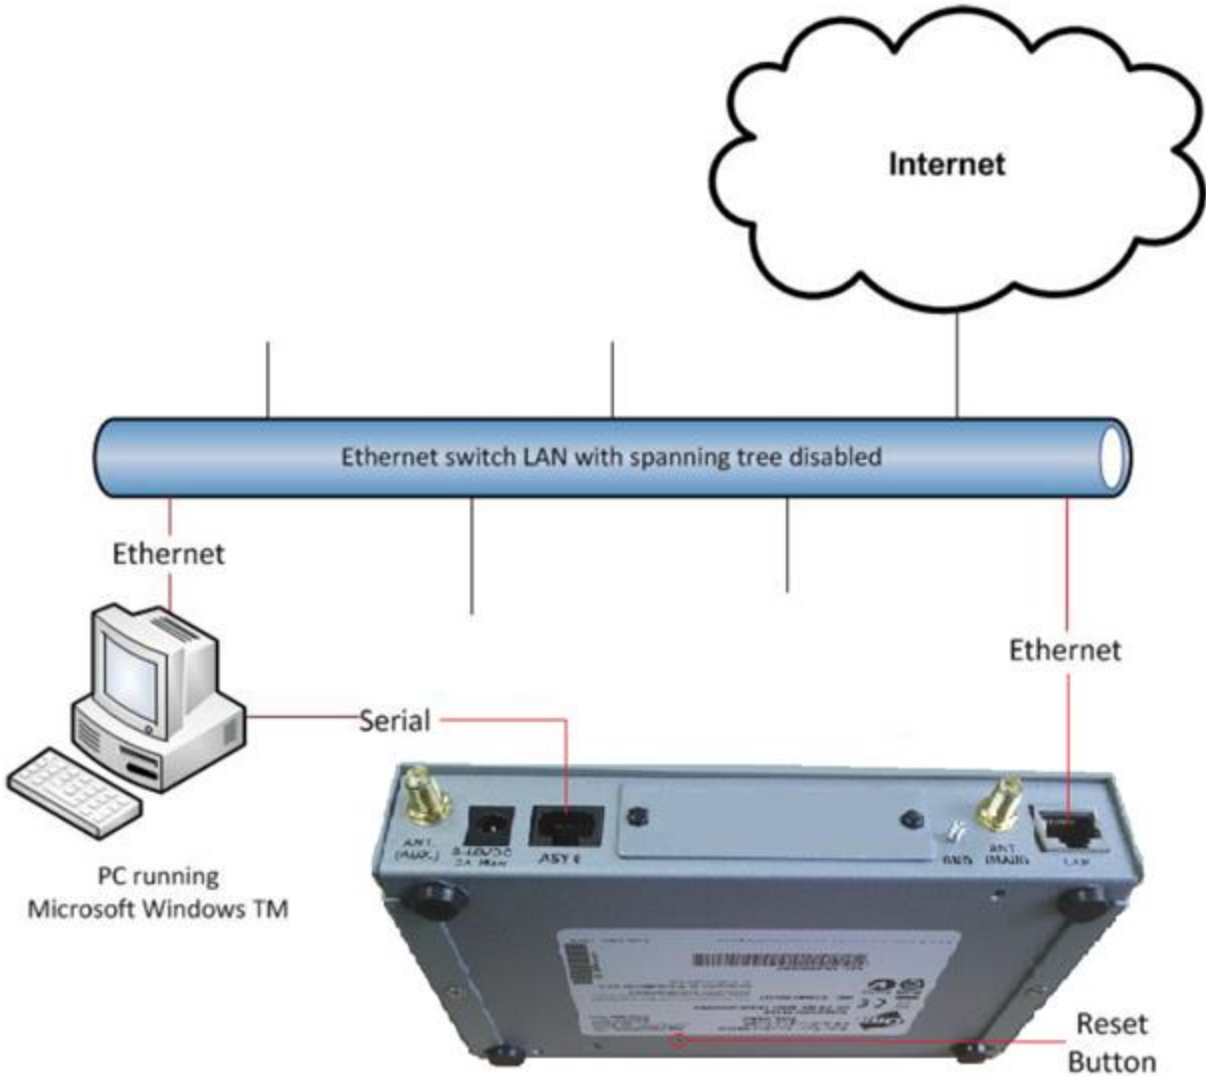
Set up the test equipment as described below.

- Connect LAN 0 of the WR41V1 to the switch/hub.
- Connect “ASY 0” the WR41V1 to the PC’s serial port 0 ideally “COM 1”.
- The Internet connection is optional and will be useful if help is required during this process from Digi Technical Support.
- Please note that the Ethernet switch/hub must not have the spanning tree protocol enabled. It is possible to use another appropriately configured WR41V1 as a switch/hub.
- It is essential that the PC’s Ethernet communication interface is configured correctly and has an IP address. The best strategy is normally to connect both your PC and the WR41V1 to your normal office LAN.
- Locate a suitable implement to depress the reset button when required.

If your PC has more than one network adapter, be sure to select the one that represents the connection to LAN illustrated in section 3. If your PC only has a single network adapter this screen will not appear:

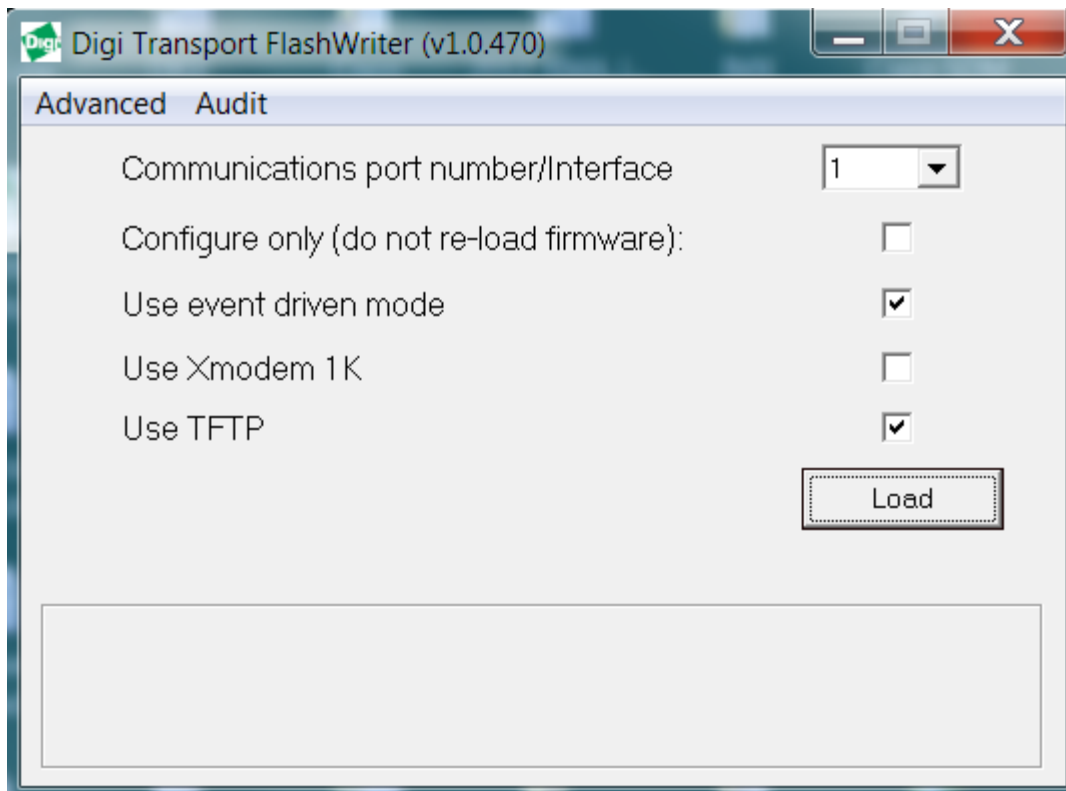
Launch Flashwriter from the start menu. Select the communications port number (PC comm. port number) to which the WR41V1 is connected. (On most PC's with a built in serial port, this will be "1" OR "2". Leave the other settings are their default values (TFTP and Event driven mode ONLY ticked):

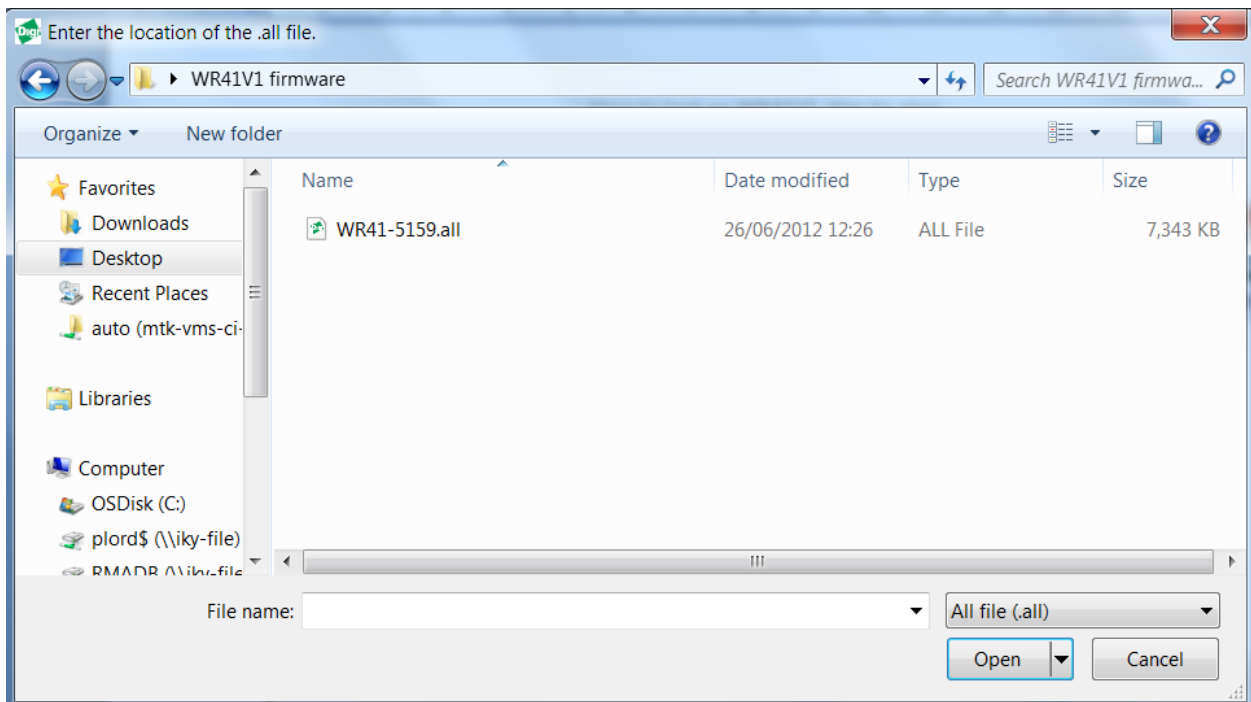
In the file dialogue, select the “ALL” file you extracted from the ZIP earlier:

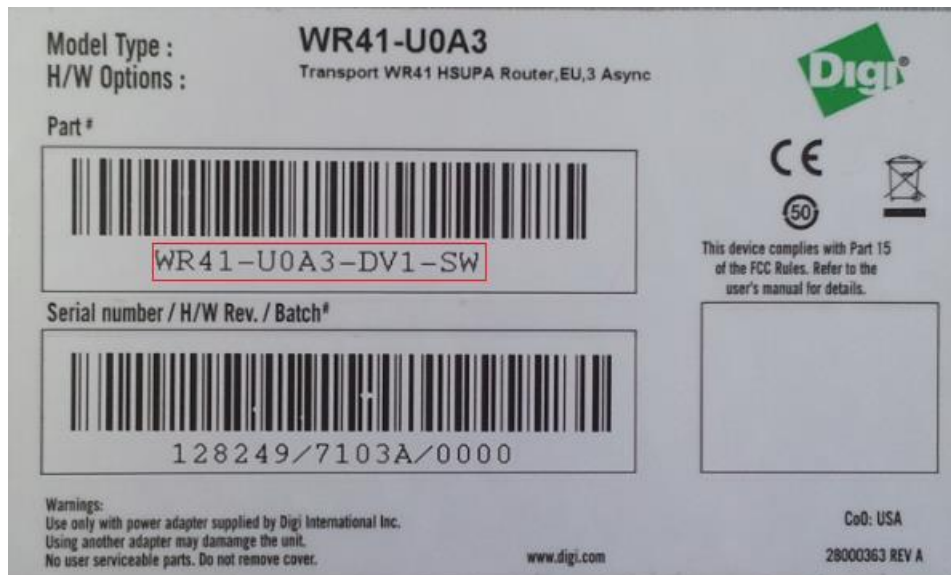
It is critical that the correct selection is made at this point. Note characters 6 and 7 of the part number (SKU) on the approval label. In the example below these are “U0”:

Refer to the following table to determine which selection to make:

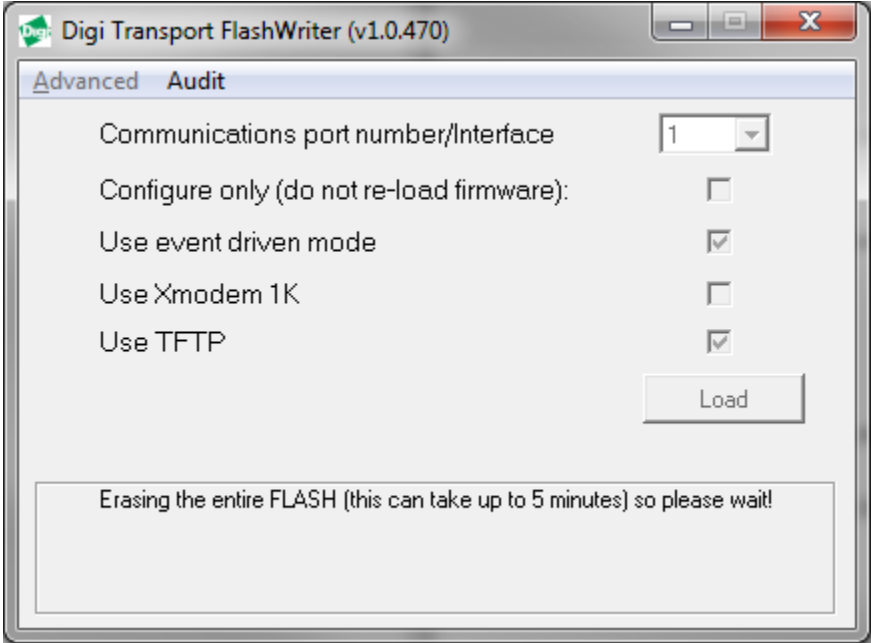
If you are successful then the following message will appear:

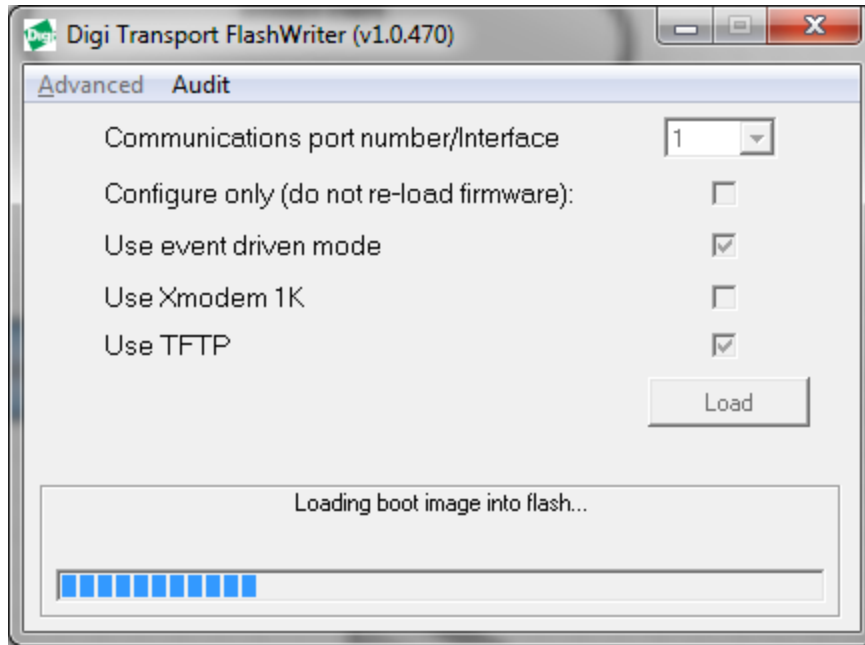
This step will take some time – please be patient. Once complete the boot image will be loaded into the flash:

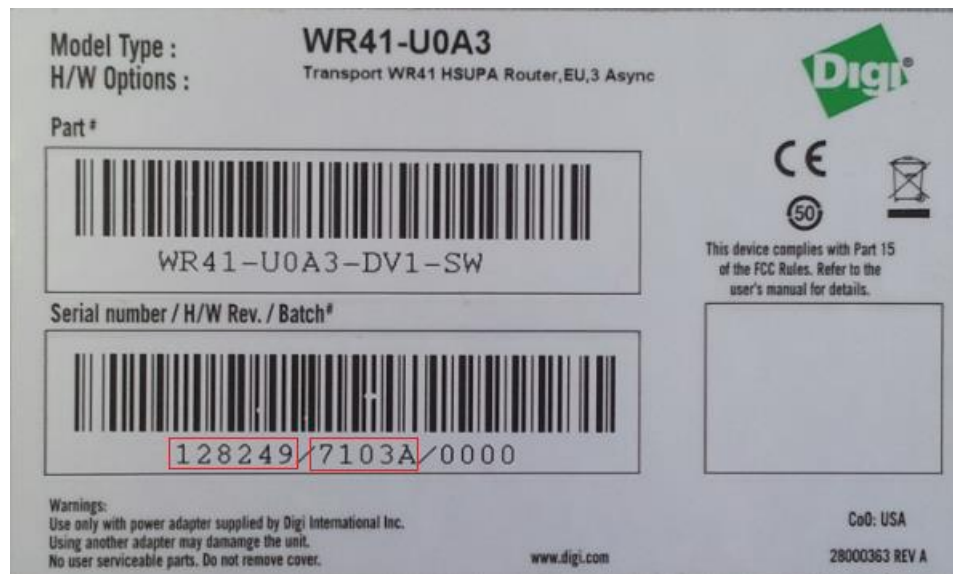
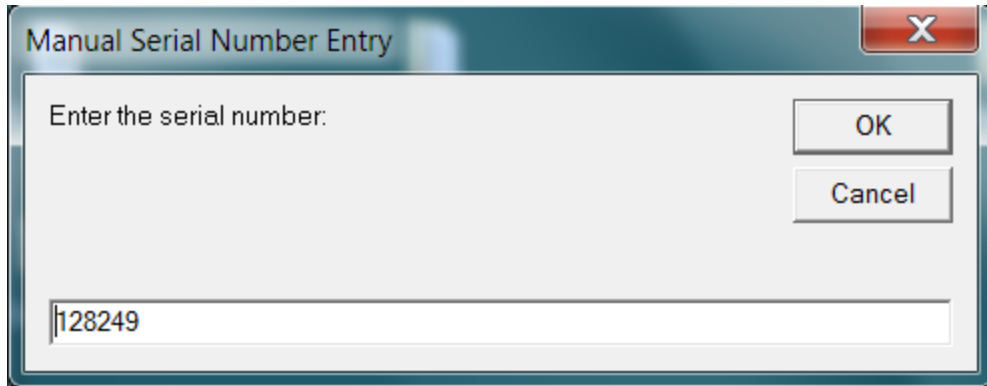
Eventually you should be prompted to enter the 6 digit serial number. (Refer to the label under the WR41V1 to find the correct serial number.)

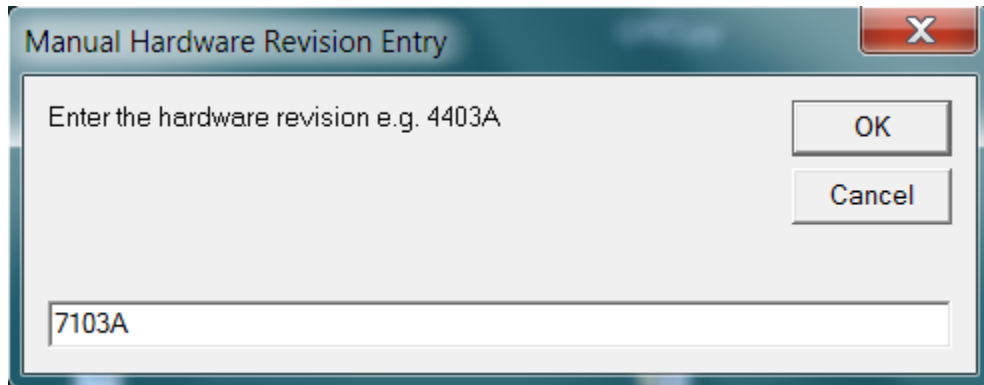
Next enter the hardware revision:

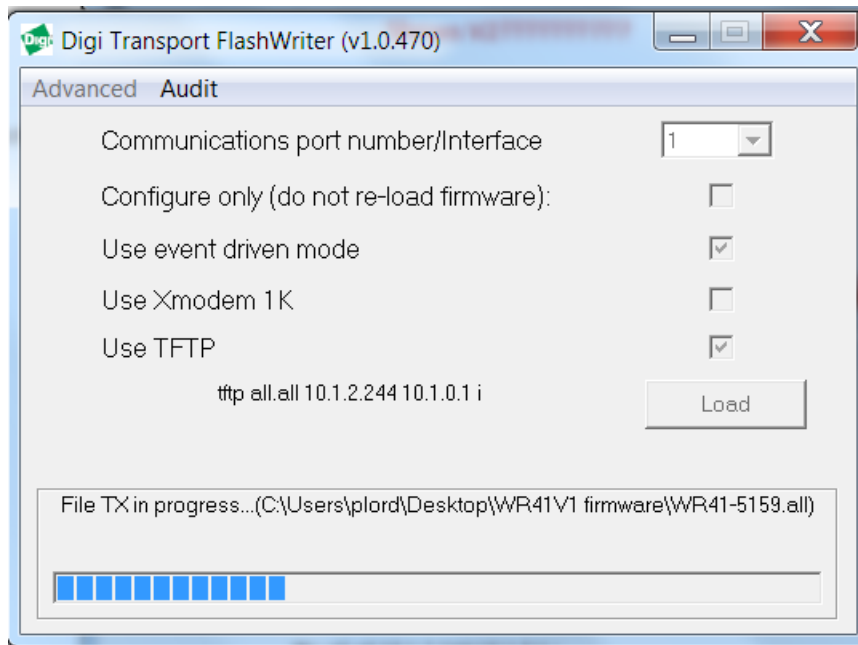
The .ALL file should start to load:

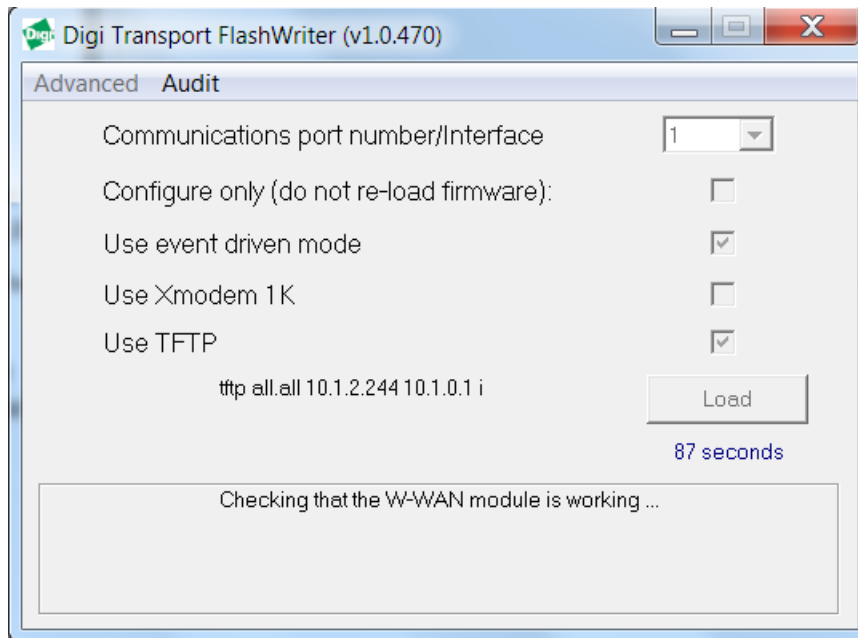
After reboot, it should check the interface to the W-WAN module (if one is fitted):

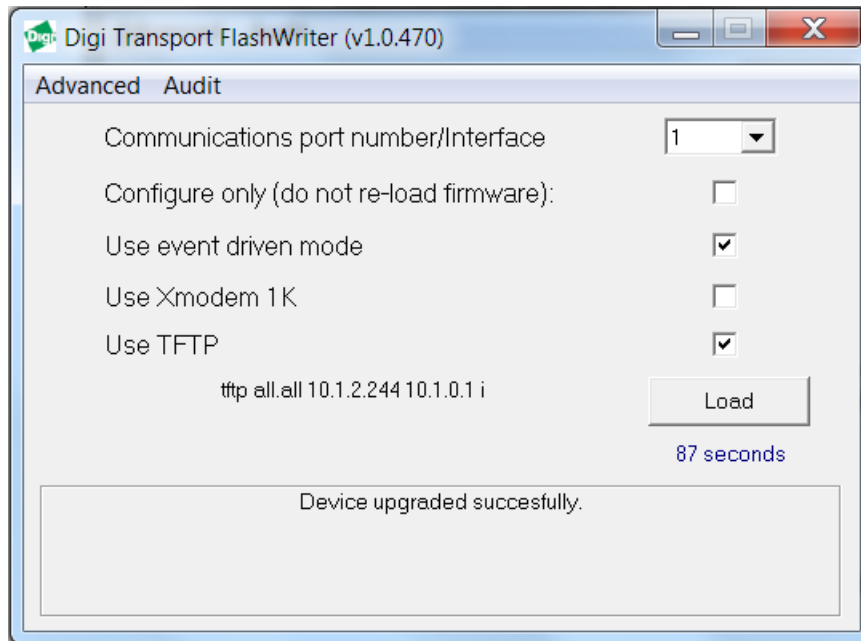
After this and other tests, it should report “Device upgraded successfully”:

This means the WR41V1 has been successfully flashed and correct communication with the internal radio module (if fitted) verified.
