iDigi Wi-9P Starter Kit ZB

ZigBee Coordinator Configuration Recovery Procedure

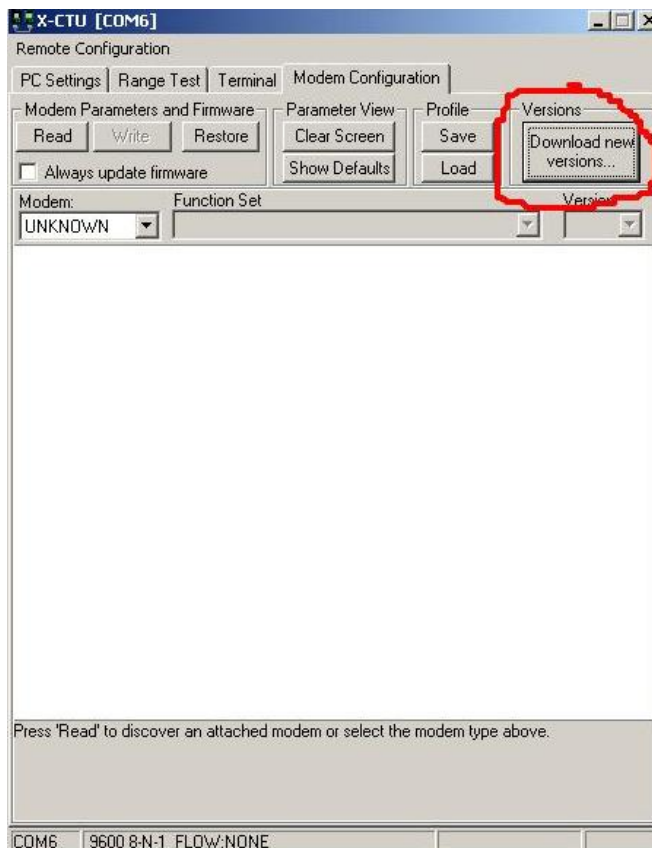
4. Prepare the XCTU utility for updating the firmware on the XBee module

- Open the XCTU utility
- Click on the 'Modem Configuration' tab
- Now click the 'Download new versions' button
- The 'Get new Versions' dialog will open
- Click the 'File' button and point it to the ZIP file (82001817_C.zip) you downloaded in step 2
- Click the 'Done' button.

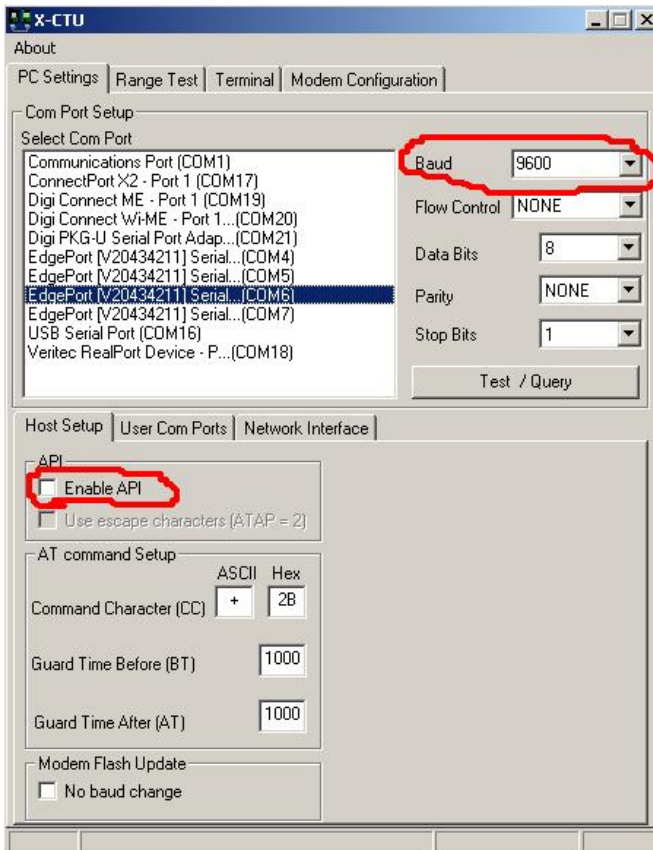
- Open XCTU and click on the 'PC Settings' tab
- Select the COM port connected to the XBee module (which is on the RS232 or USB board)
- Select a baud rate of 9,600
- Click on the 'Host Setup' tab

- Make sure the 'Enable API' box is unchecked

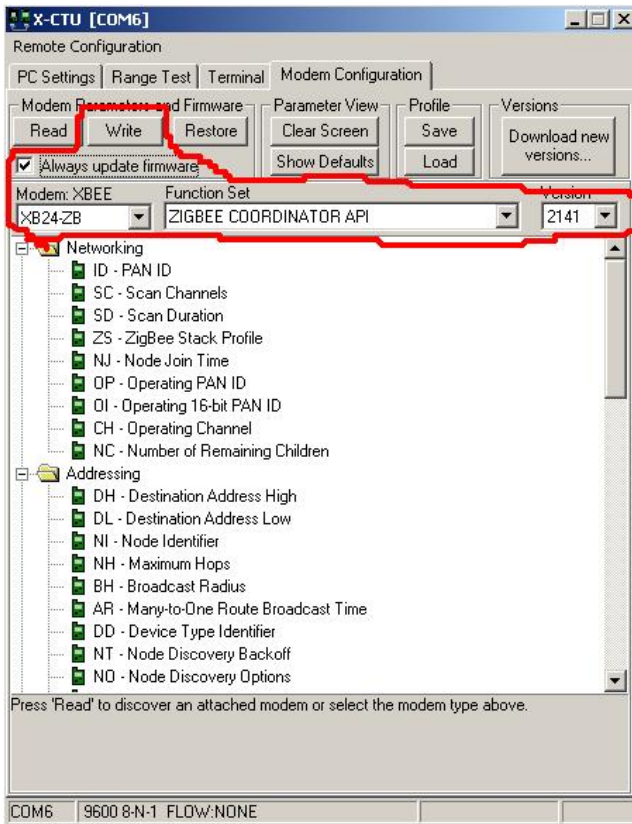
- Now click on the 'Modem Configuration' tab.
- Select 'XB24-ZB' under 'Modem: XBee'
- Select 'ZIGBEE COORDINATOR API' under 'Function List'
- Select '2141' under 'Version'
- **Note:** The option '2141' will not be visible if you did not pick the proper firmware version as outlined in step 2!
- Check the 'Always update firmware' box
- Click on the 'Write' button to initiate the firmware update

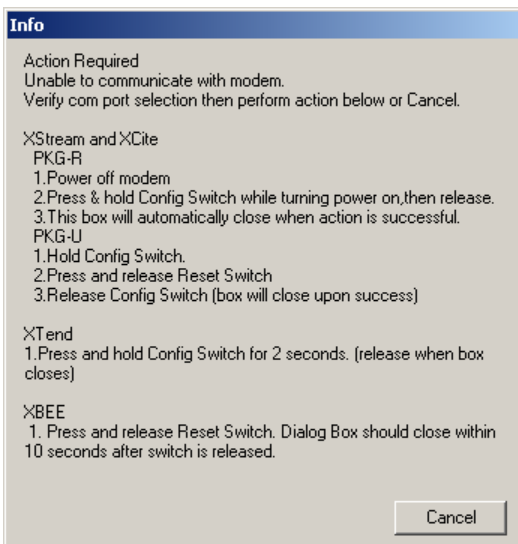
After a moment, you will see a dialog box asking you to reset the XBee module.

Now press the reset button on the XBee carrier board.

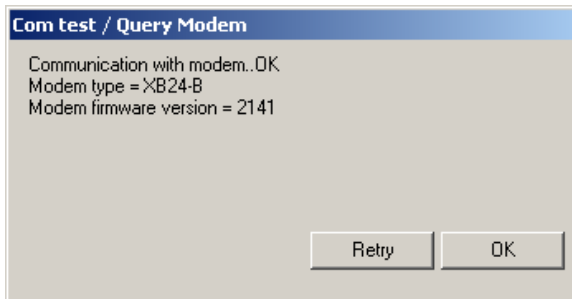
Note: You can verify the successful firmware update by going back to the 'PC Setting' tab, selecting the 'Host Setup' tab, checking 'Enable API', and then selecting the 'Test/Query' button. The modem should respond with its firmware version (see below).

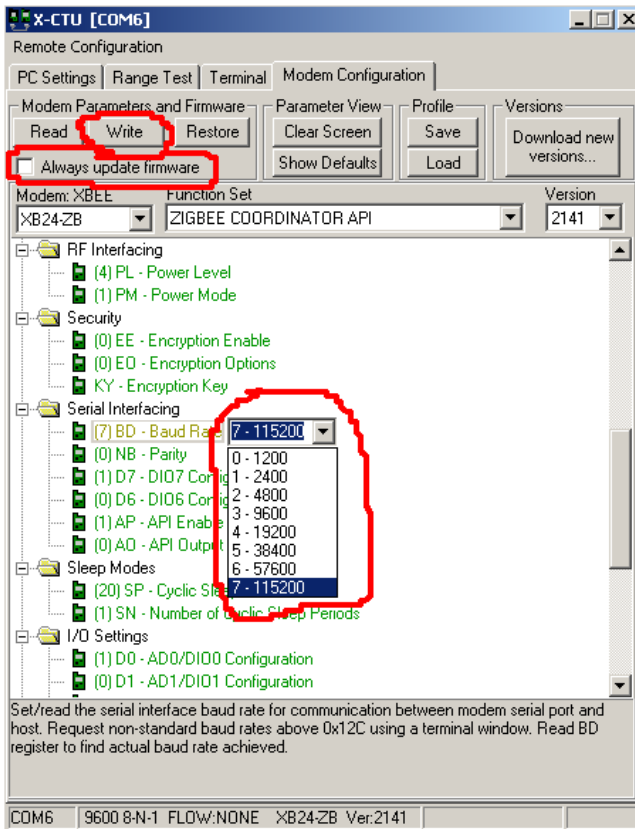
- Now go back to the 'Modem Configuration' tab
- Press the 'Read' button
- Scroll down to the 'Serial Interfacing' section
- Click on ' BD - Baud Rate' and change the value to '7 – 115200'
- Now uncheck the 'Always update firmware' box and press the 'Write' button

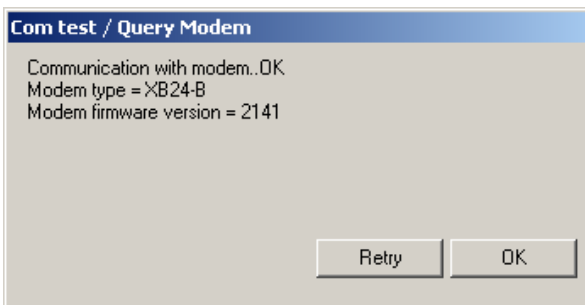
Note: You can verify the successful firmware update by going back to the 'PC Setting' tab, selecting the 'Host Setup' tab, checking 'Enable API', and then selecting the 'Test/Query' button. The modem should respond with its firmware version (see below).
